SYLVANIA

GENERAL TELEPHONE & ELECTRONICS
FACTORY PREPARED
TECHNICAL SERVICE DATA

SUPPLEMENT 1 TO BULLETIN
S32-6

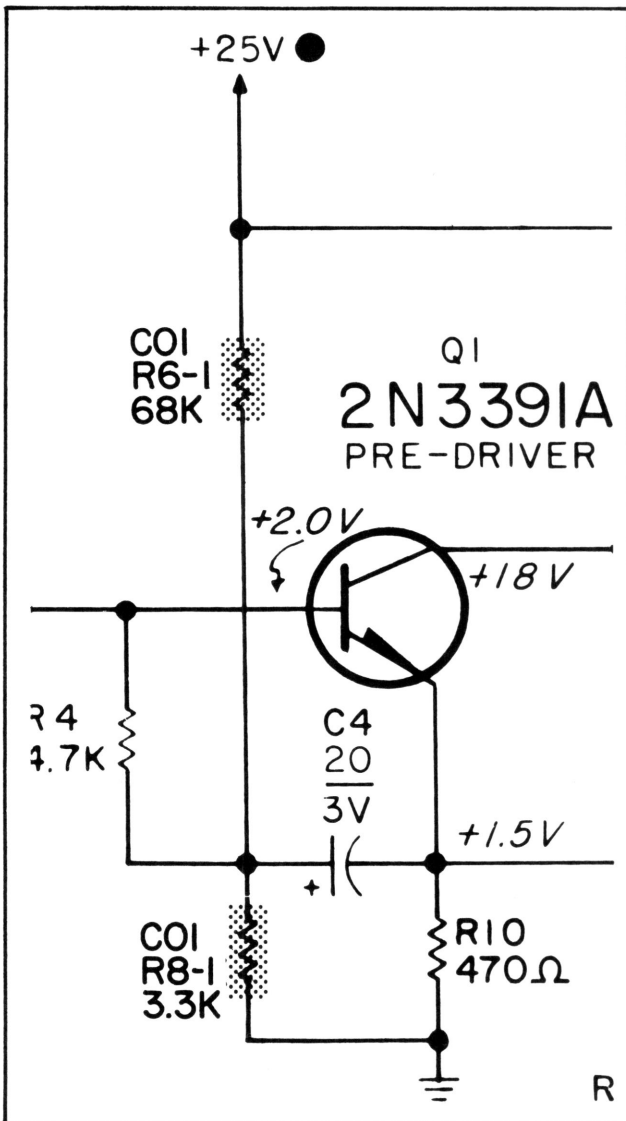
Figure 1

REASON: R72 and R74 overheating at high line voltage with high Beta driver transistors.

1. R6 (56K) changed to R6-1 (68K). See Fig. 1.
2. R8 (4.7K) changed to R8-1 (3.3K). See Fig. 1.
3. R40 (56K) changed to R40-1 (68K). See Fig. 2.
4. R42 (4.7K) changed to R42-1 (3.3K). See Fig. 2.

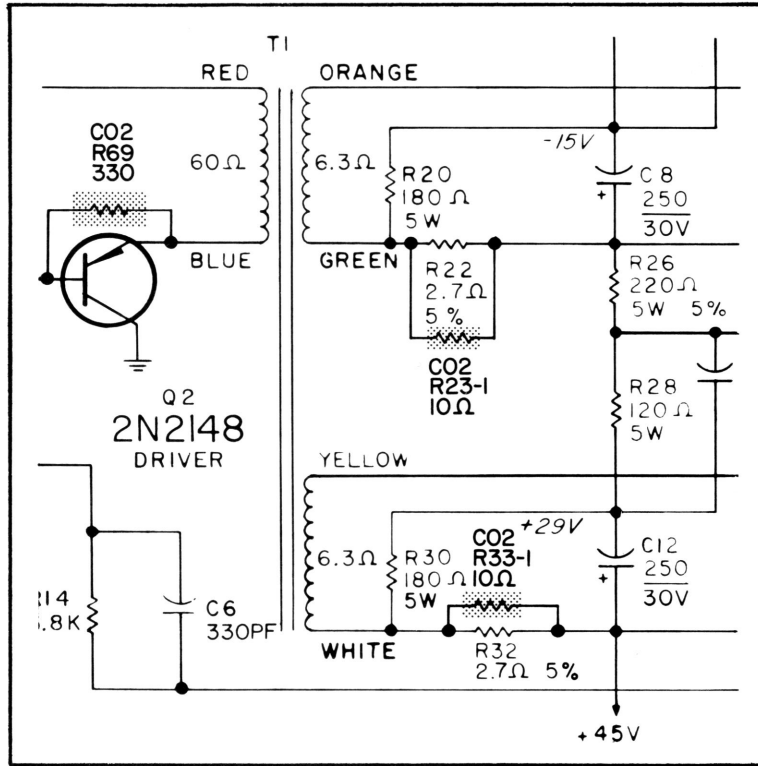
Figure 3

REASON: Q2 and Q8 biasing changed.

1. R23 (6.8 ohm) changed to R23-1 (10 ohm). See Fig. 3.
2. R33 (6.8 ohm) changed to R33-1 (10 ohm). See Fig. 3.
3. R57 (6.8 ohm) changed to R57-1 (10 ohm). See Fig. 4.
4. R67 (6.8 ohm) changed to R67-1 (10 ohm). See Fig. 4.
